LCQ NETWORKING NOTES

For NT 4.0

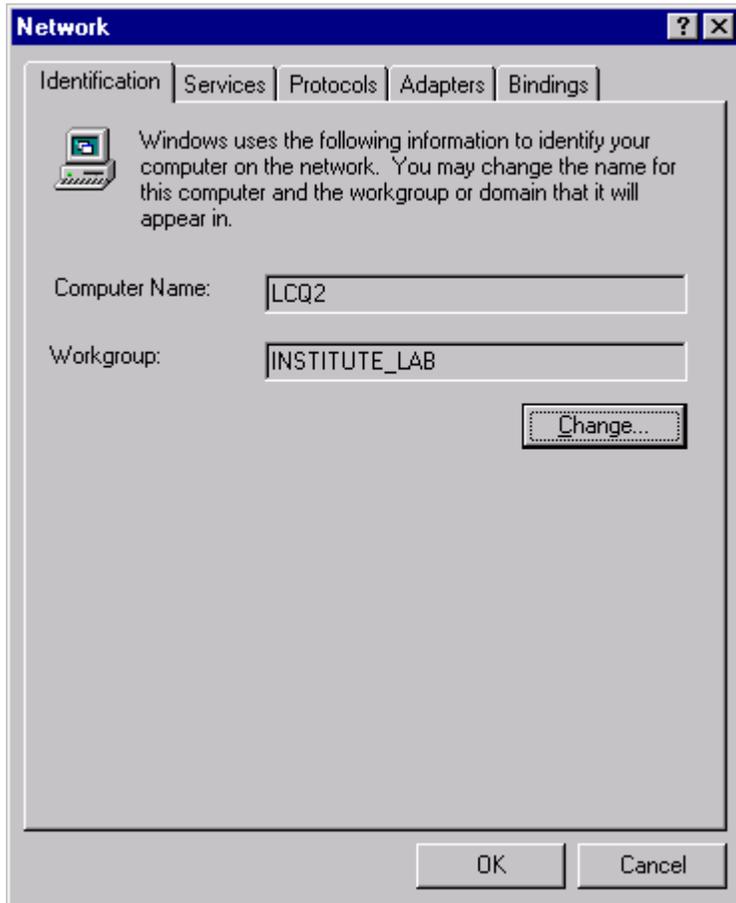
Look at the network settings by using these selections:
Start - Settings - Control Panel - Network

You get something like this:

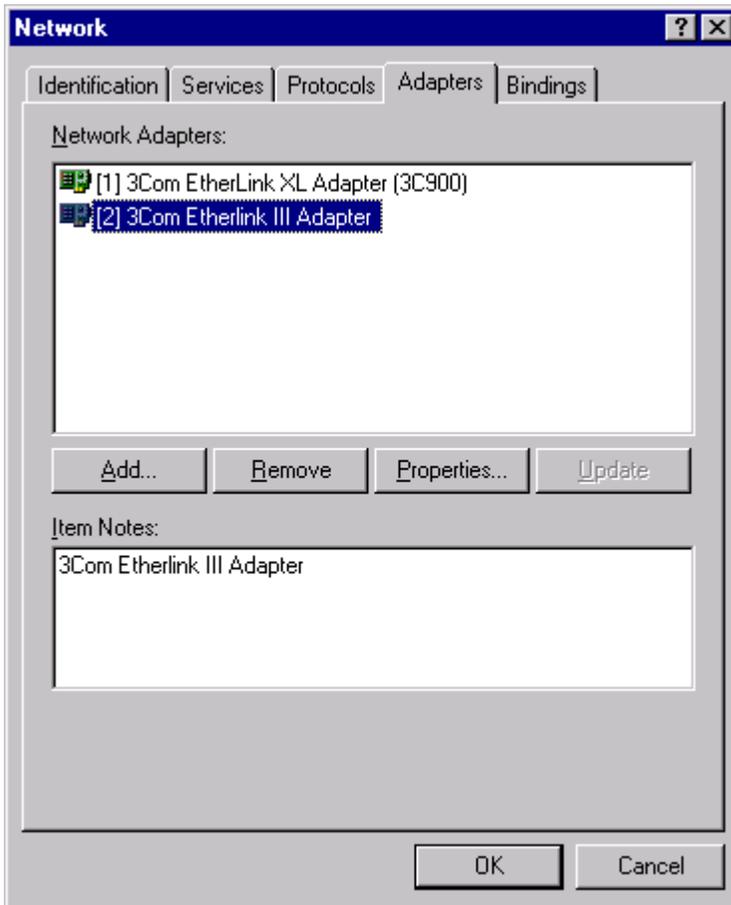
Select Adapters. You should get this box. The Etherlink III card is the one that Finnigan assigns to the LCQ. The Etherlink XL is for the customer's network.

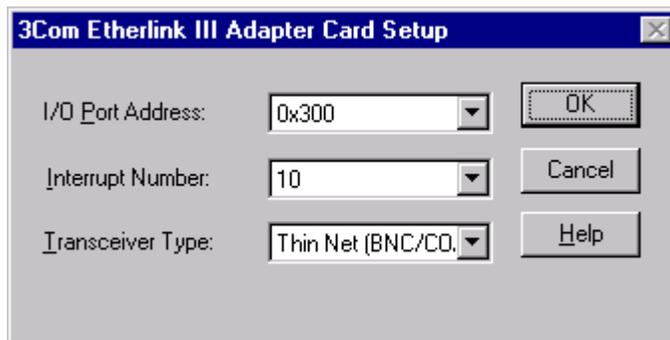
Select Properties for the Etherlink III. You should get this:

The card goes on the ISA number 0 bus.
Cancel out of this screen if everything is correct.

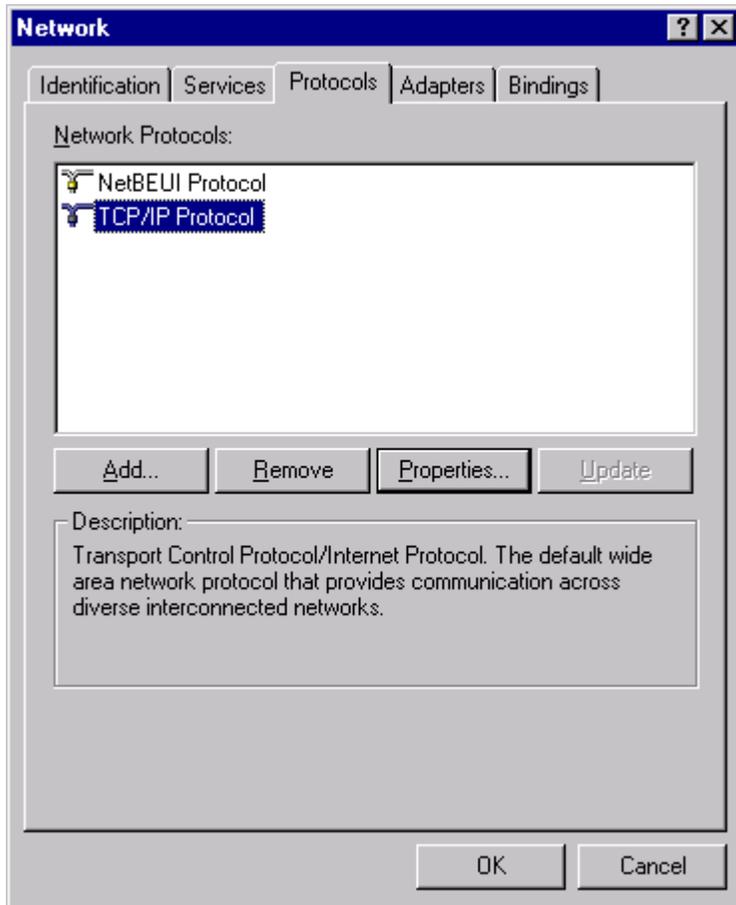
Next Select Protocols for the Etherlink III adapter. You should get this box. For LCQ communications we must have NetBEUI and TCP/IP. Other protocols used by the customer's network may be listed.

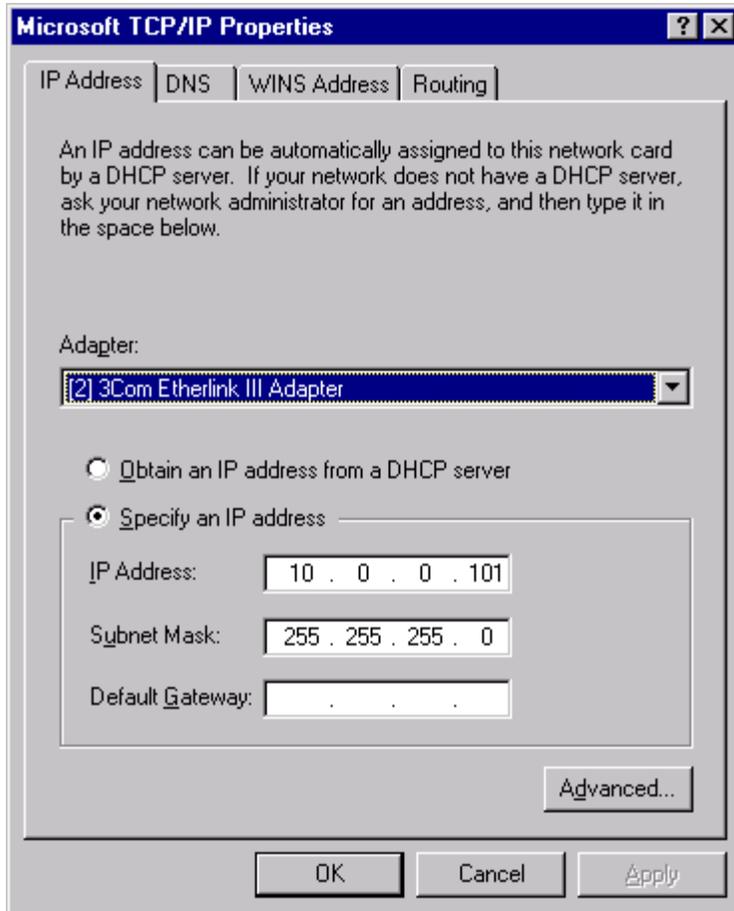
Next select TCP/IP and then the Etherlink III. You should get this. **It is critical that the IP address and subnet mask match this.** Many times MIS people will modify this address when making connections to their in-house network.

Our software addresses the Etherlink III card with the IP address 10.0.0.101. The card we put in the LCQ has an IP address of 10.0.0.201. Our instrument manager software talks to these two addresses. The Instrument Manager will not start if 10.0.0.101 cannot be found in the Gateway computer. This is most likely the problem if the LCQ communications have been lost after an MIS group has connected the Gateway computer to their network.

The IP address of the LCQ's network card is 10.0.0.201.

The IP address of the NT computer's card is 10.0.0.101.

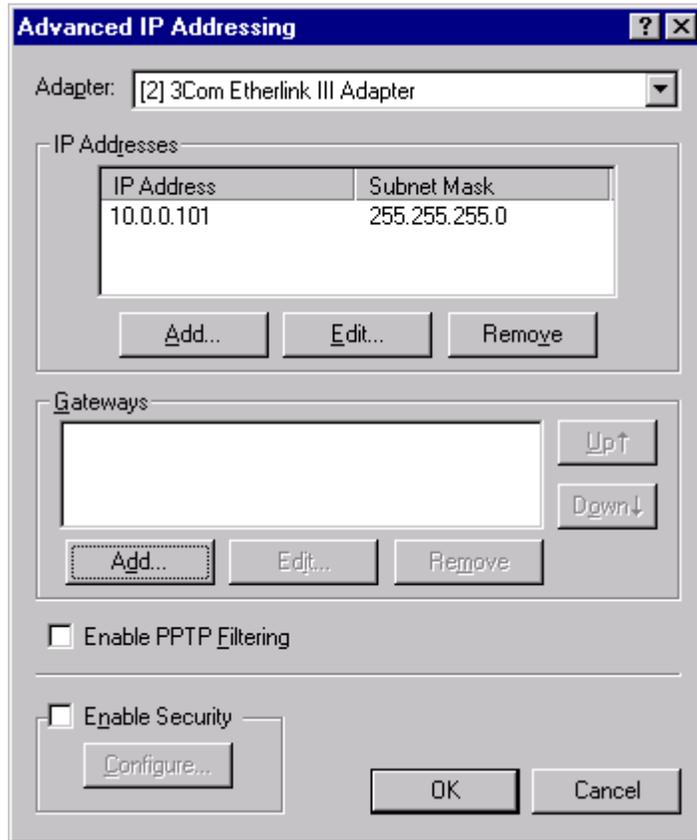
Click on Advanced, you should see this:

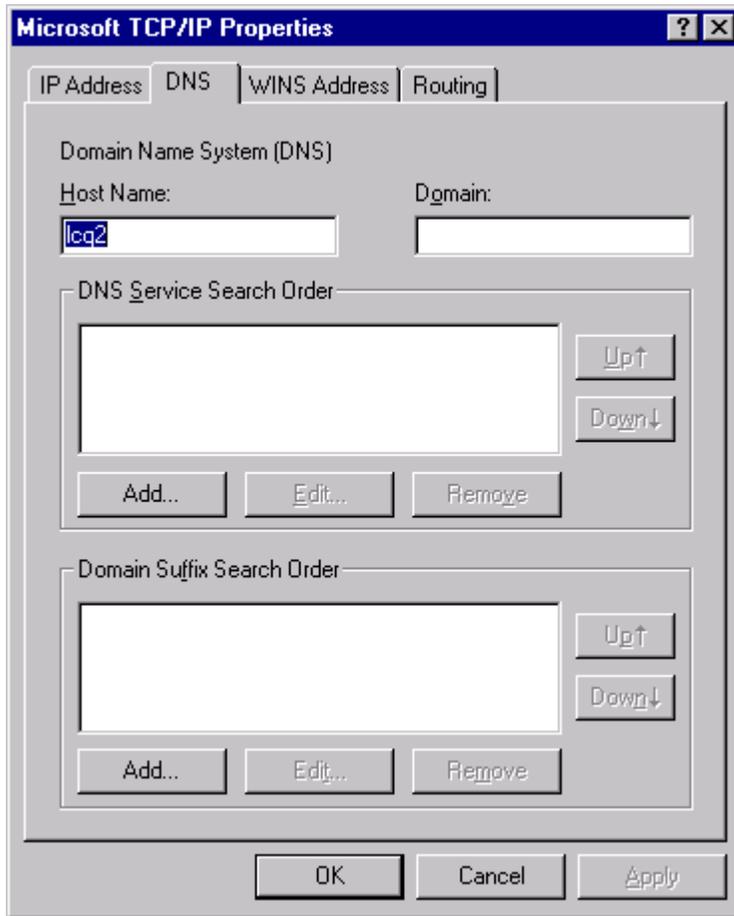
Next go to the DNS tab. The host name should be the same as the computer name in the first network screen.

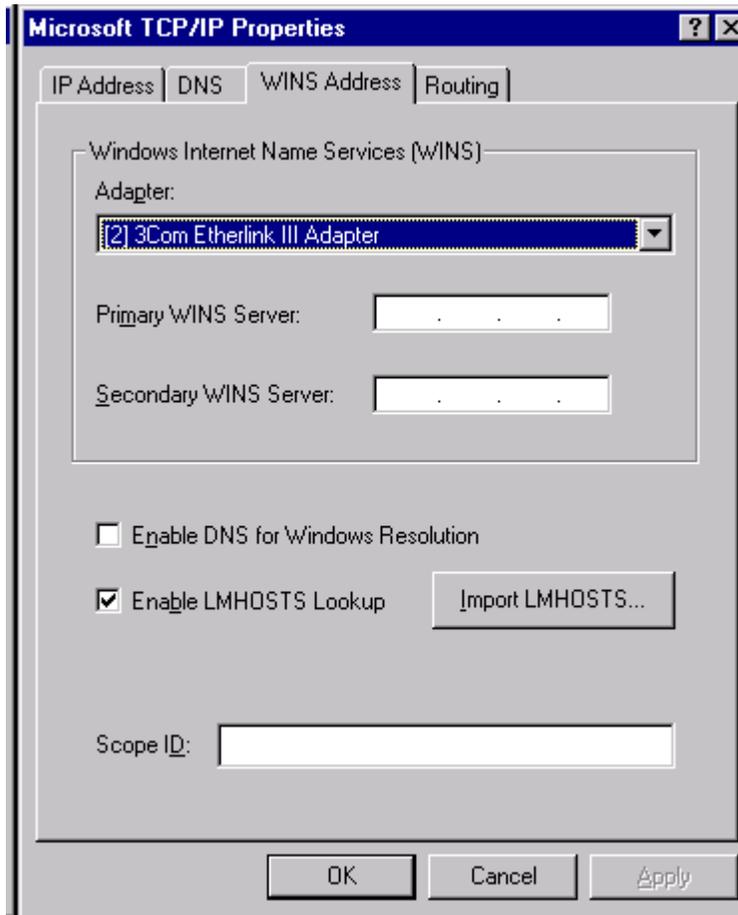
Go to the WINS Address tab. You should see this.

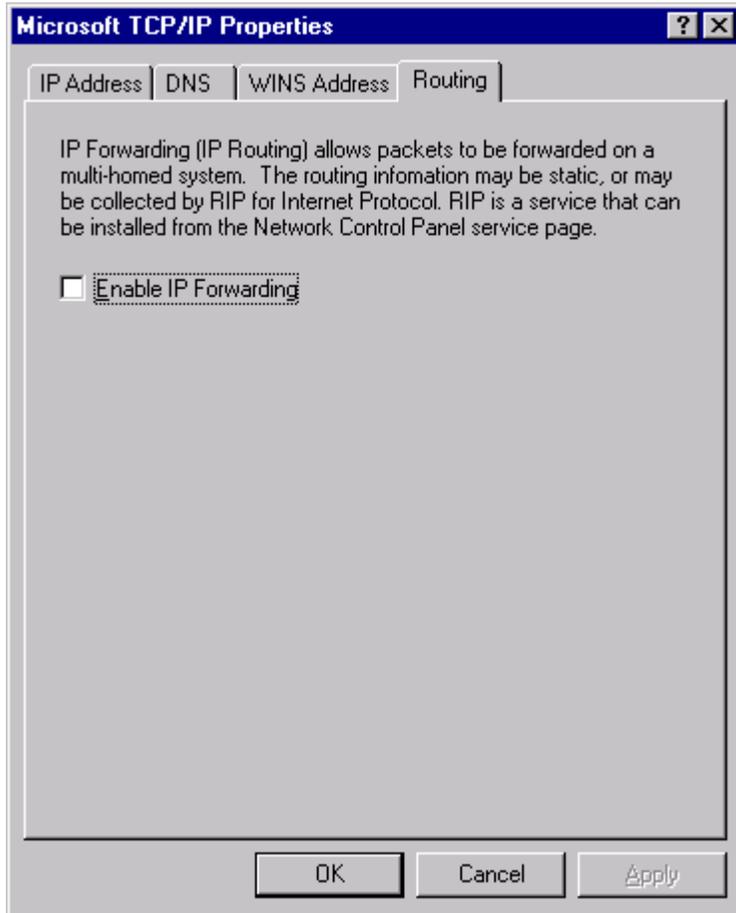
To be complete go to the Routing tab. You should not see IP forwarding checked.

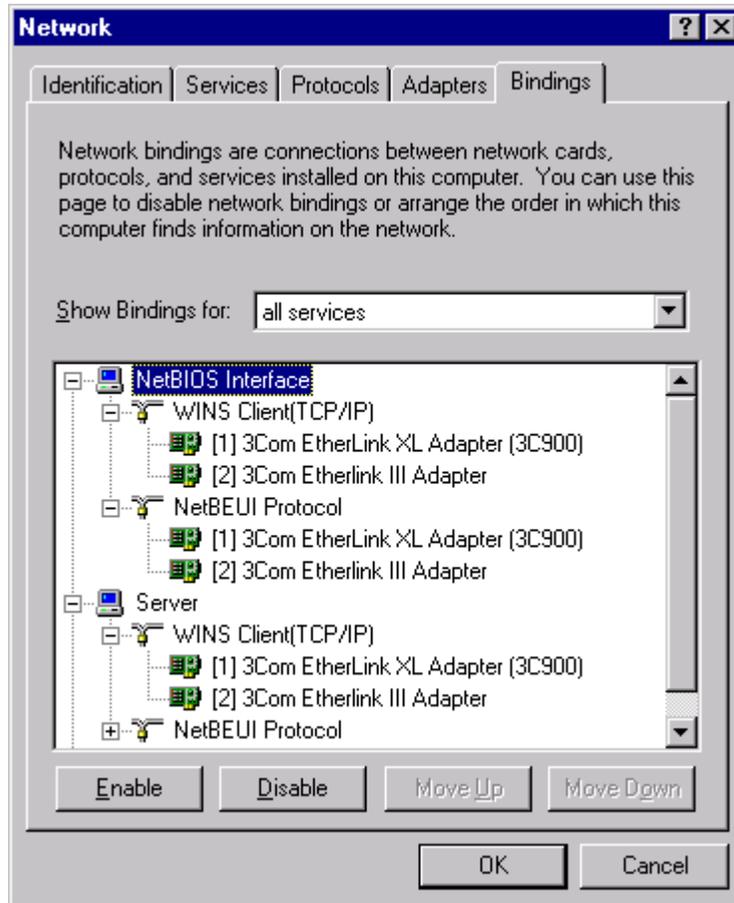
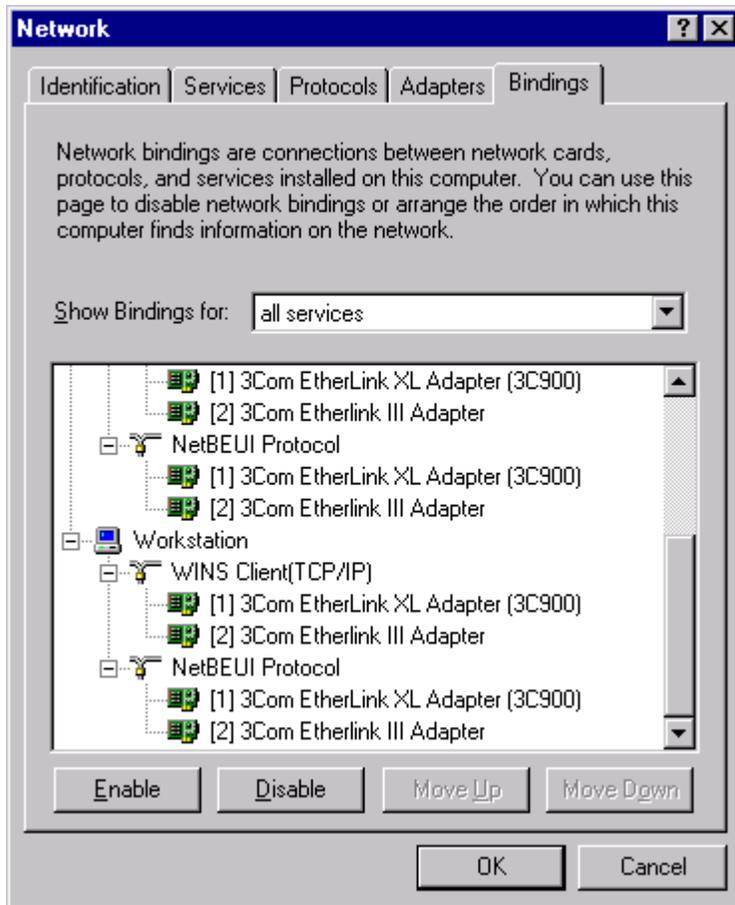
Bindings should not be critical. However these are the working settings.
